## **Newtonville Commuter Rail Station: A Photo Essay**

This document explores the Newtonville commuter rail station via a sequence of photos and comments. The goal is to illustrate why enhancing the commuter rail service in Newton may be possible but difficult.

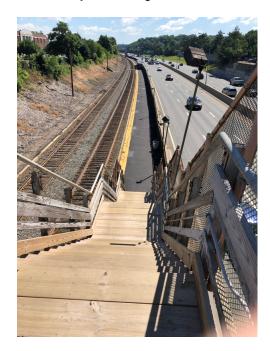
1. View of the Walnut St stairs to the platform

Immediate observations:

- There are 36 steps down.
- The walkable width of the steps is 65 inches.
- There is only one functioning platform which is located on the south side of the tracks between the tracks and the turnpike.
- Trains stop at a small covered zone which is halfway between Walnut St and Harvard St.
  This is a long walk from either set of stairs.
- The stairs and most of the platform has no protection from the elements: sun, rain, or snow.
- There is no handicap accessibility.

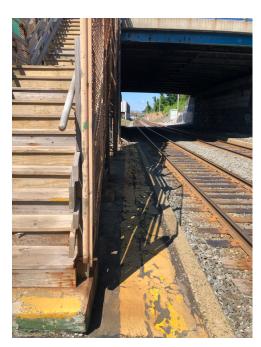
3. Walnut St stairs closeup

The closeup photo of the Walnut St stairs shows that there is currently not enough width between the stairs as built and the train tracks for a wheel chair to pass even if a standard elevator were constructed from the Walnut St overpass down to the platform level.

The platform width at Walnut St is 12 feet but the centered location of the stairs relative to the platform precludes a path wide enough for a wheel chair on either side. We believe that it would be best to shift the stairs towards the tracks to then provide a wide enough and safe path to accomodate a wheel chair between the stairs and the chain link fence.

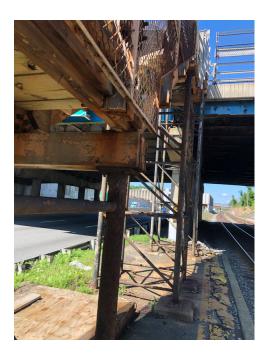
4. Underneath the Walnut St stairs

The photo underneath the Walnut St stairs shows a tangle of beams and scaffolding. To achieve an accessible entrance with a standard elevator at Walnut St, a complete rebuild of the stair structure would be needed.

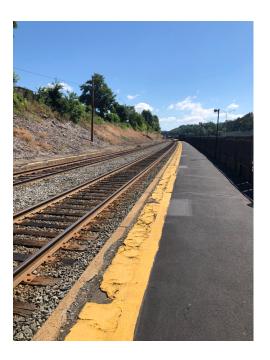
5. Remnants of an old north side platform

It was fascinating to discover that there once was a north side platform in Newtonville. Presumably, when this north side platform was functional, east bound trains used the south side track and west bound trains used the north side track and there was no need for track switching. All trains that stopped, could stop at an appropriate platform.

One thought is to rebuild the north side platform, make it accessible as well, and enable trains to stop at both the south platform (eastbound) and the north platform (westbound). Doing this at all three Newton stations is the key infrastructure requirement needed to expand service in the city.

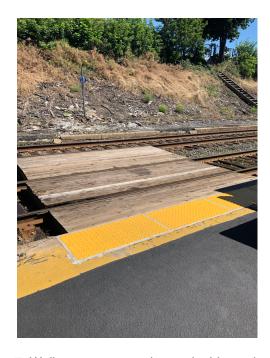
7. Walkway to access the north side track

The flag stops in Newton are a bit problematic. It is not clear from the schedule if and when these trains are routed to the south side track (platform side). In cases where a flag train happens to be on the north side track, the wooden walkway is used to provide access to the train. In that case, the walkway location is the only place where passengers may enter or exit the train. This is certainly an additional accessibility issue.

One workman was adding extra nails to the walkway from the platform to the north track to keep the boards from becoming loose and poking upwards. The fact that this work was being done means that the walkway must be in active use at least for some flag stops in Newton.

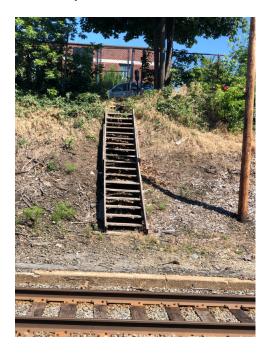
8. Steps to a locked Washington St gate

The steps to Washington St opposite the covered portion of the platform are curious. The gate at the top of the steps is locked and the steps have no hand rails. The steps are clearly not intended for the general public.

The steps are intended for service personnel who need more direct access to the platform in special circumstances. I confirmed this on a recent visit to the Newtonville station in mid-morning. The gate was unlocked and several workmen were doing tasks.

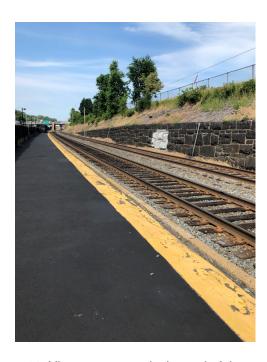
View west towards the end of the old north side platform

The "view west" photo in Newtonville shows a retaining wall on the north side of the tracks that quickly becomes quite tall. I think that it would be very problematic to cut into this wall and attempt to move it closer to Washington St in order to extend a rebuilt north side platform all the way to Harvard St.

I think that a rebuilt north side platform will likely have more or less the same length as the unused platform that exists now. In particular, accessible access to a north side Newtonville station may only be possible from Walnut St and from Washington St.

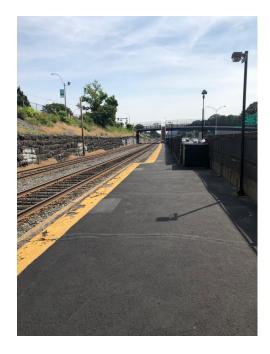
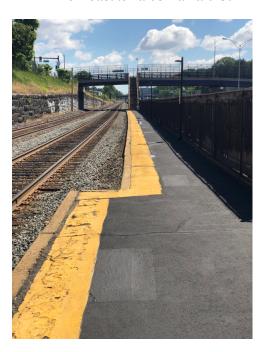
Looking at the two "view east" photos, you can see that the Newtonville platform becomes significantly narrower near Harvard St. First, the chain link fence that separates the platform from the turnpike has been inset left by 55 inches. Second, the asphalt of the platform has been inset right by 39 inches. Before the inset occurs, the platform is 192 inches = 16 feet wide. After the inset, the platform width is narrowed to 98 inches = 8 feet 2 inches. The width has been almost cut in half at this point. By the time that the platform reaches the Harvard St stairs, its width has narrowed even further to 86 inches = 7 feet 2 inches.

To make the existing south side platform accessible from Harvard St end is difficult because of the gratuitous narrowing of the platform at the Harvard St end. However, if the 55 inch fence inset is eliminated and the fence is moved back closer to the turnpike then there would be room for a wide enough path from an elevator at Harvard St to the south side platform.

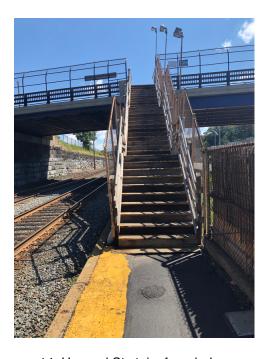
14. Harvard St stairs from below

The Harvard St stairs have 34 steps and the walkable width is 61 inches. Adding the width taken up by the structure of the stairs, there is little clearance to get past the stairs and currently little reason to do so.

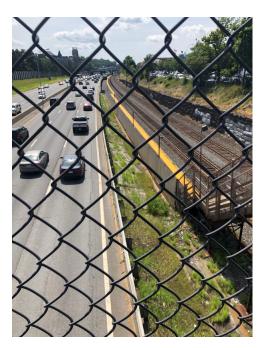
15. Inset space between the Harvard St end of the platform and the Turnpike

The final photo taken from above the Harvard St stairs shows what is behind the section of fence that has been inset by 55 inches. The answer is: nothing of value. There is grass, weeds, and random debris.
